**Trial to demonstrate the effectiveness of a
'PondTec 50' Ultrasonic Unit in
eliminating a bloom of blue-green algae
Oscillatoria sp at
“The Doughnut Pool”
Whitmore Fisheries
Nr Blackpool
Lancashire**

September 2010

Sustainable Soil & Water Ltd

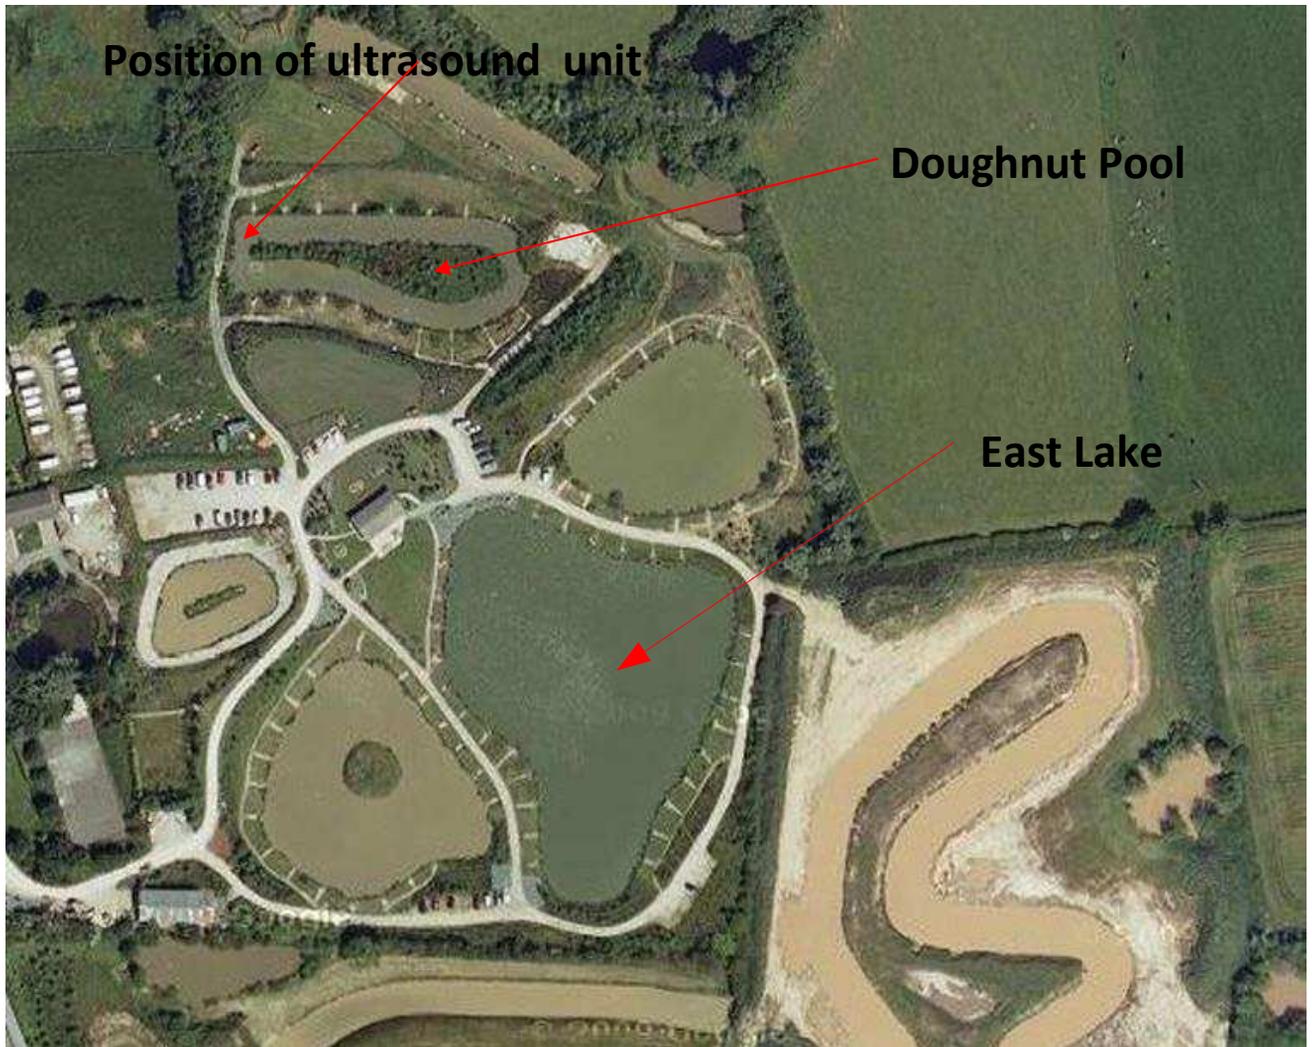
Whitmore Fisheries Layout

The East Lake was the primary source of the algal infestation.

This lake overflows into the Doughnut Pool.

The presence of the blue-green algae is clearly visible in the East Lake and Doughnut Pool even in this satellite photograph.

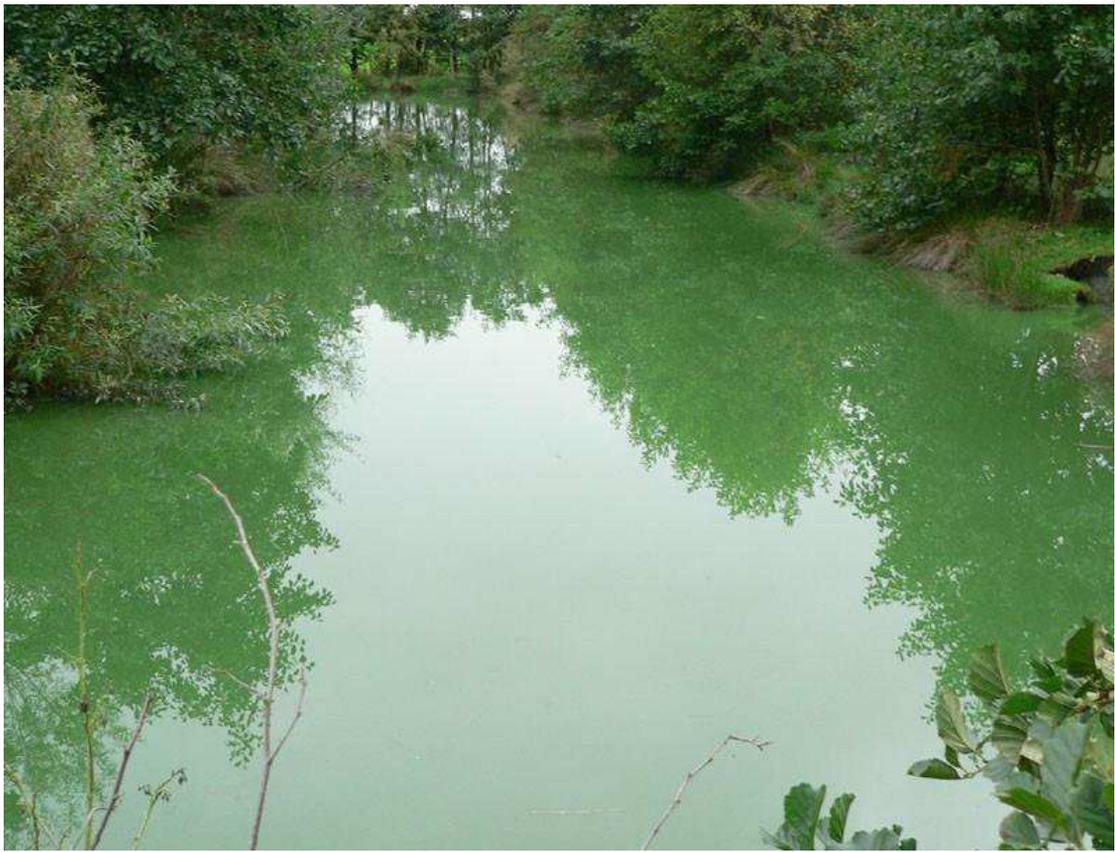
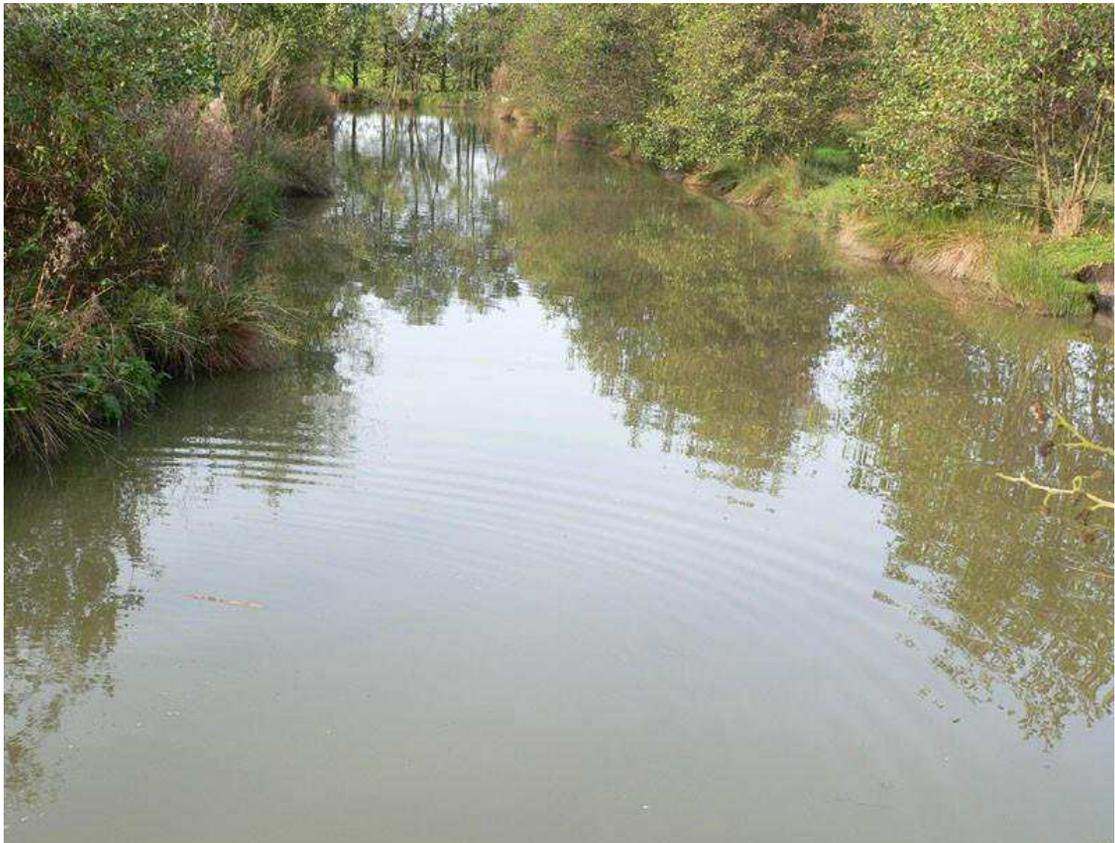
Looking towards Ultrasound unit. Above before – below after treatment

For the first 2 weeks of the trial, water from the also infected East Lake was over-flowing into this pool making the task difficult. Once this flow was halted, the *Oscillatoria* was eliminated within 10 days. Water temperature was not a contributing factor here, as the blue-green algae in the West Lake was still in abundance.

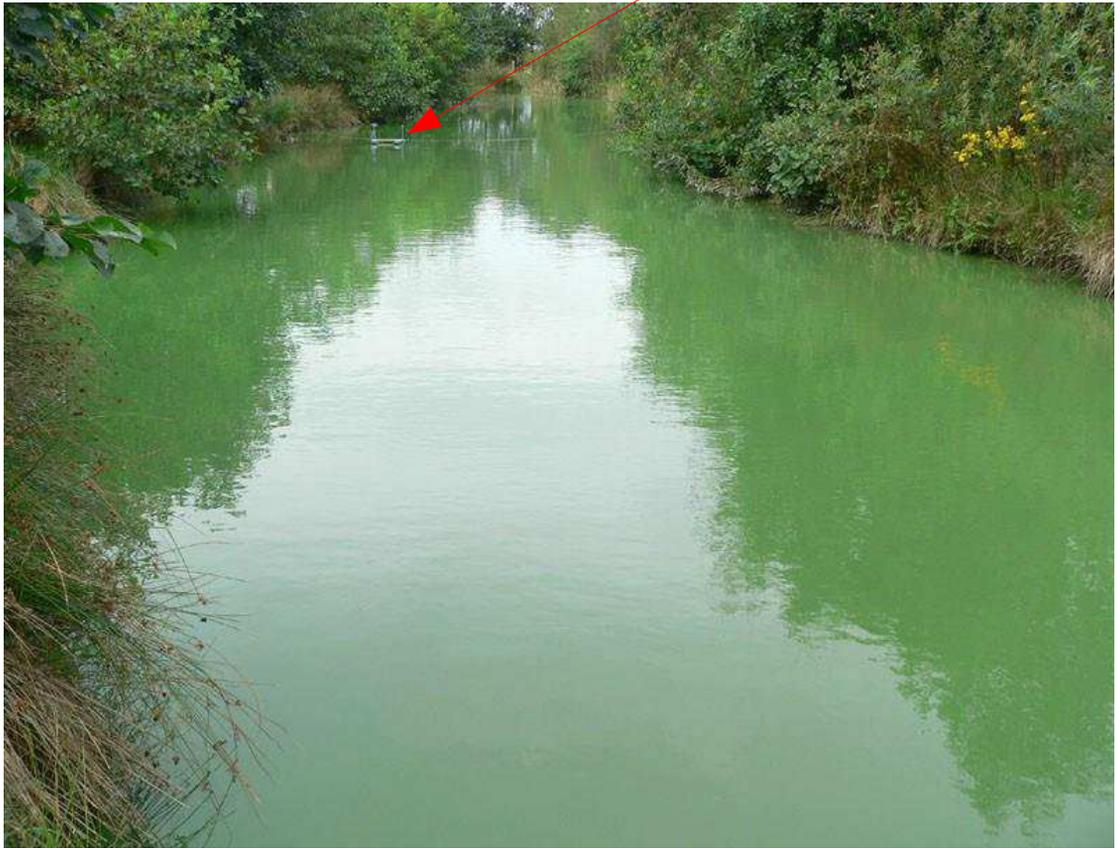
Aerator unit

In mid September 2010 a PondTec 50 ultrasound unit in the Doughnut Pool. During the period of the trial, the pond was aerated using an aerator supplied by Aquaculture Equipment Ltd – this was an important requisite because as the blue-green algae was killed off, oxygen levels would drop with the potential for major fish kill. The results were very impressive.

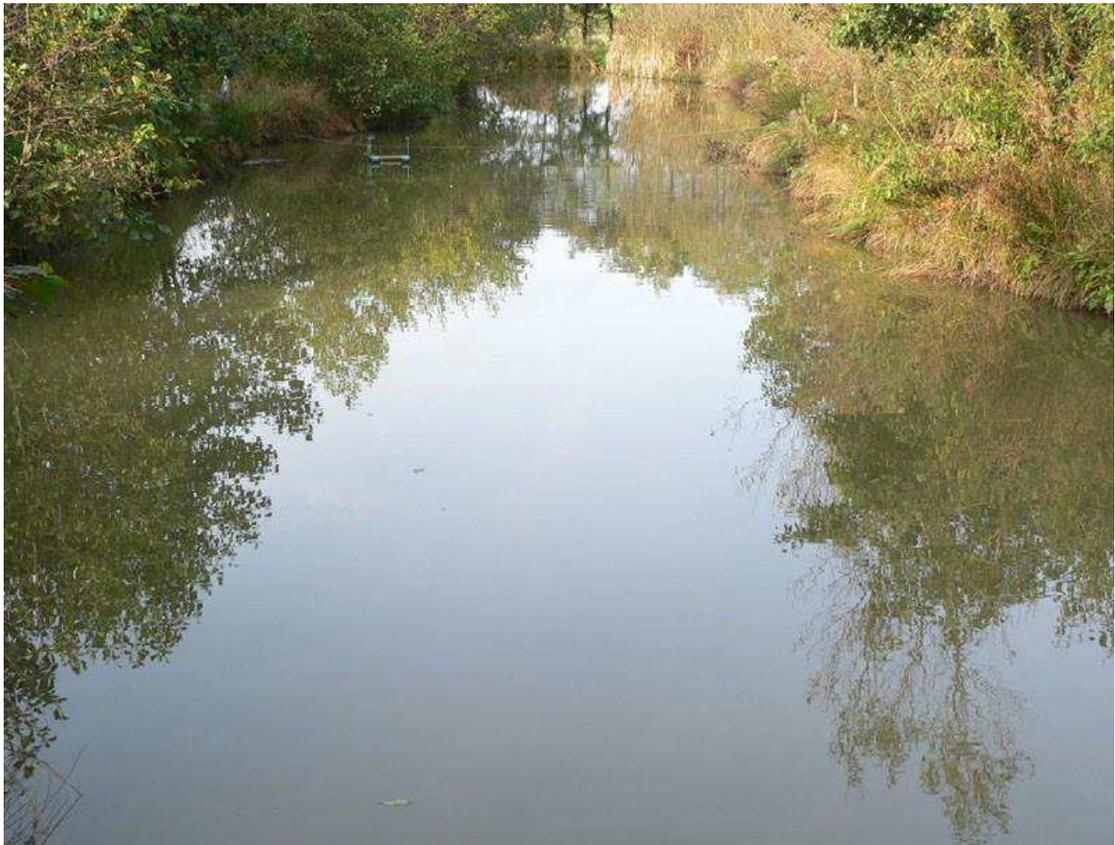
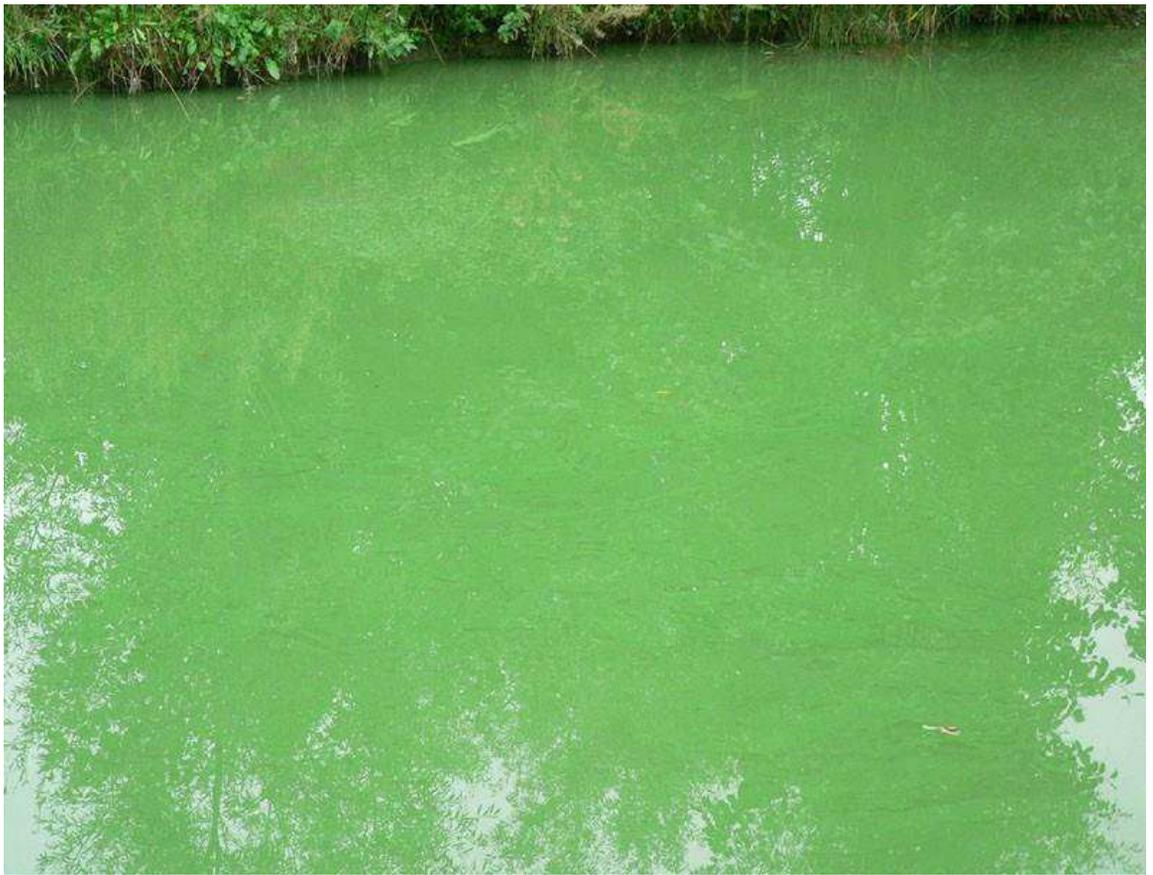
Other side of the pool. Above before – below after treatment

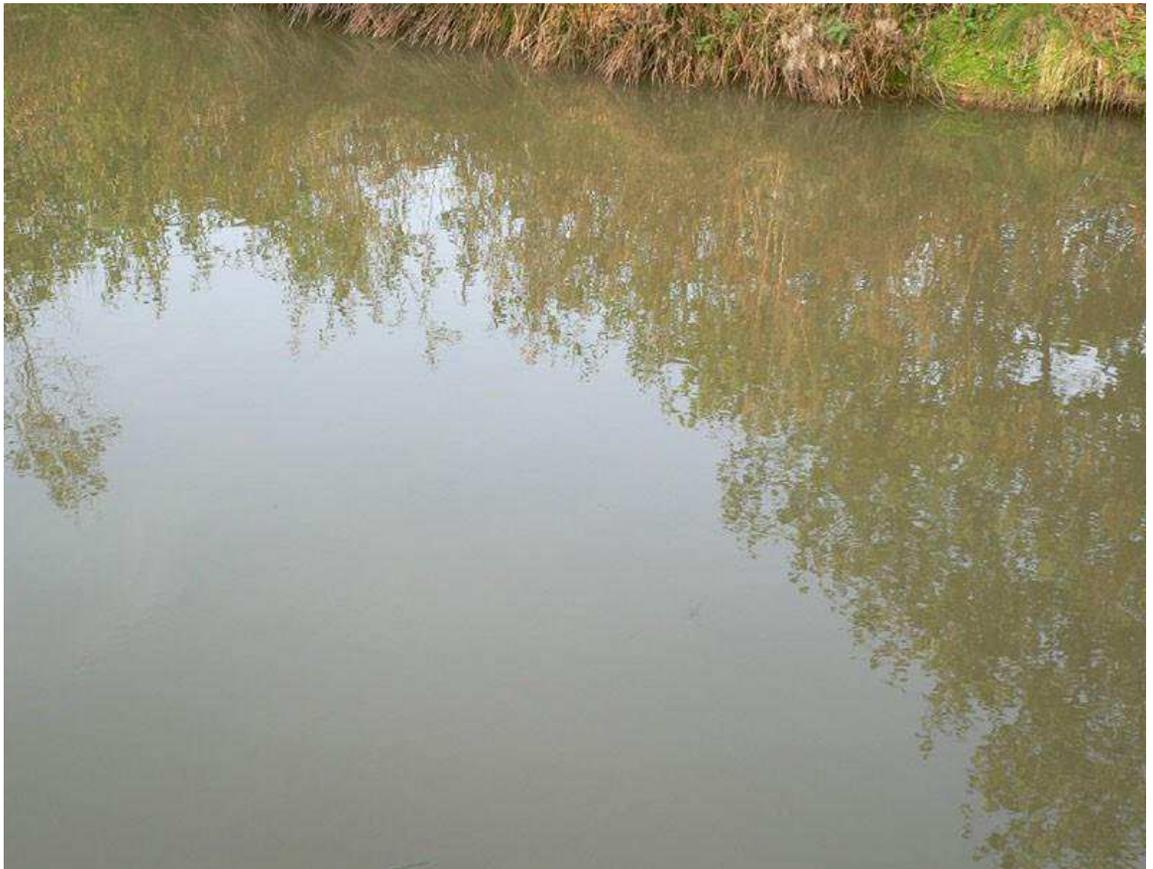
Close up of pool. Above before – below after treatment
