Smart Heating Boiler De-Calcification & Legionella prevention Testimonial

Initial Requirement: Testing the effectiveness of using ultrasound to control legionella and calcification in an industrial boiler system.

Munchen StadtWerke (Municipal Service Company of Munich, Germany), maintains immersion heating systems on behalf of regional customers, including those in the Taufkirchen district of Munich.

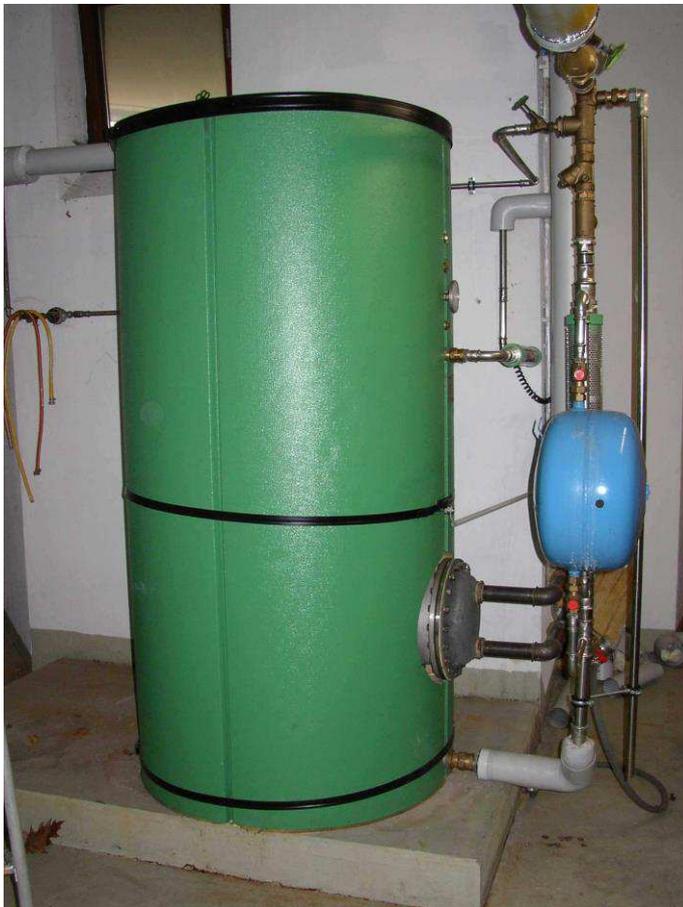
These boiler systems (Fig. 1), typically comprise an arrangement where the secondary water for customer use, is heated by having a heat exchanger tube bundle (Fig. 2) immersed within it, through which the primary hot water is passed. The primary and secondary water circuits are kept separate from each other.

(Fig. 1) Warm Water Boiler 2000 L capacity

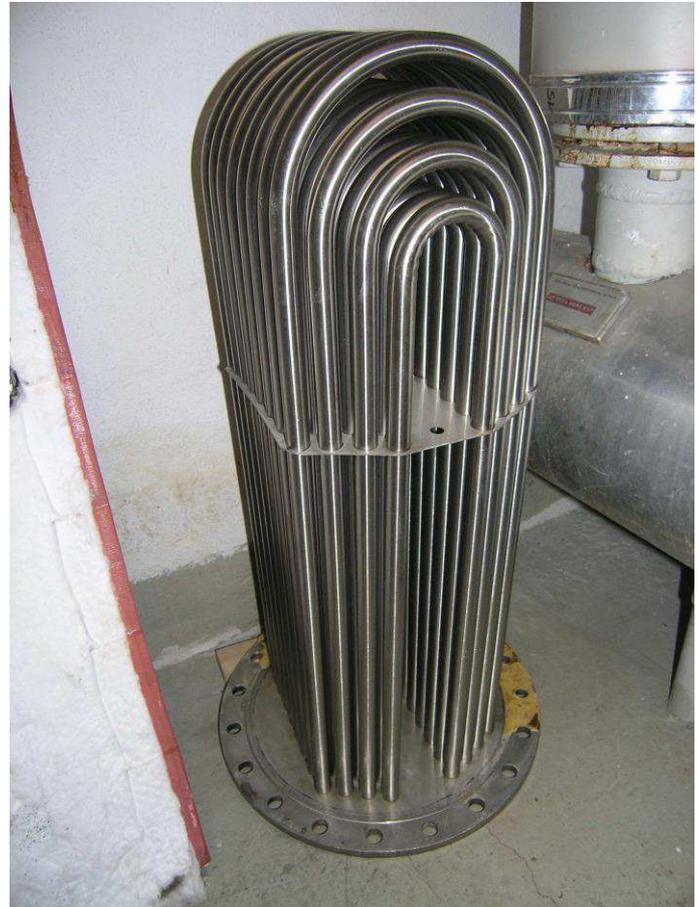
(Fig. 2) Internal Heat Exchanger tube bundle (cleaned)

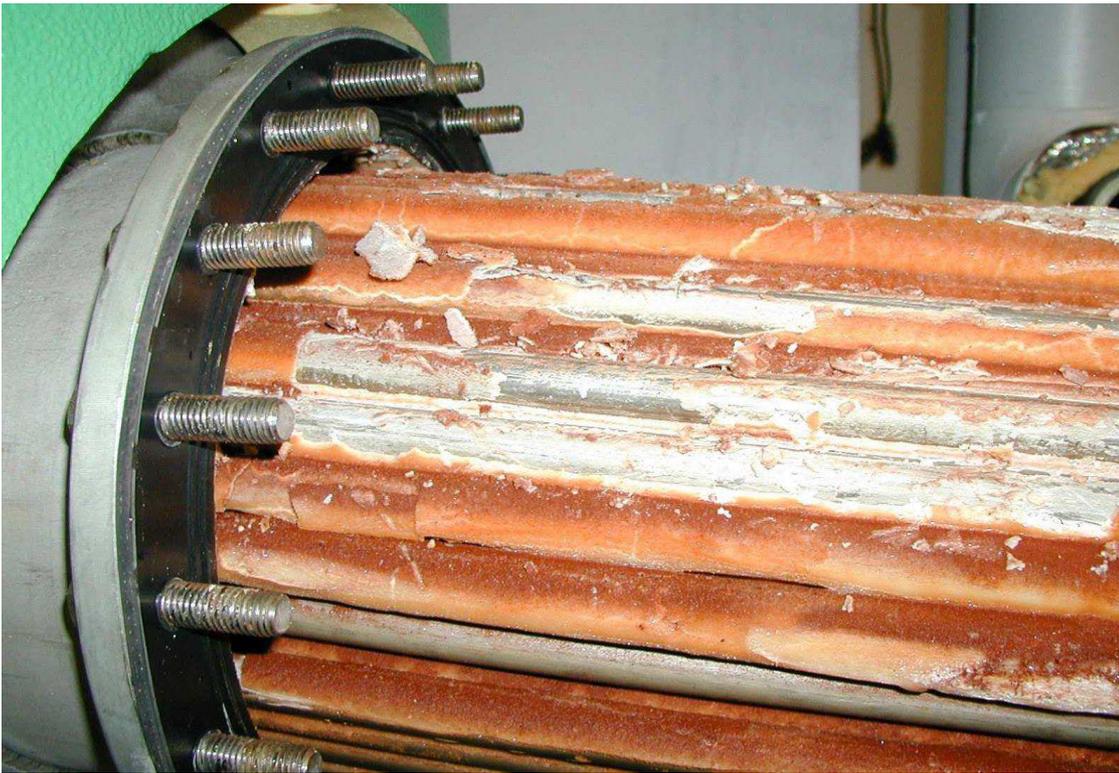
Additionally, since the water in the region is very hard, lime-scale deposits become attached to the heat exchanger bundles after a period of use. (Fig. 3 and Fig. 4)

(Fig. 3) Calcification of the heat exchanger bundle after 12 months

Once the heat exchanger becomes heavily calcified, heat transfer is significantly reduced and energy efficiency decreases, preventing a guaranteed permanent secondary water temperature of 55° C for customer use being achieved. Also, the preventative diurnal water heating cycle temperature of 80° C can-not be reached within the expected 1 hour time period, for the process of killing bacteria.

Consequently, the heat exchangers must be serviced and cleaned every 12 months by a special boiler descaling company, which cleans the bundle using an acid bath.

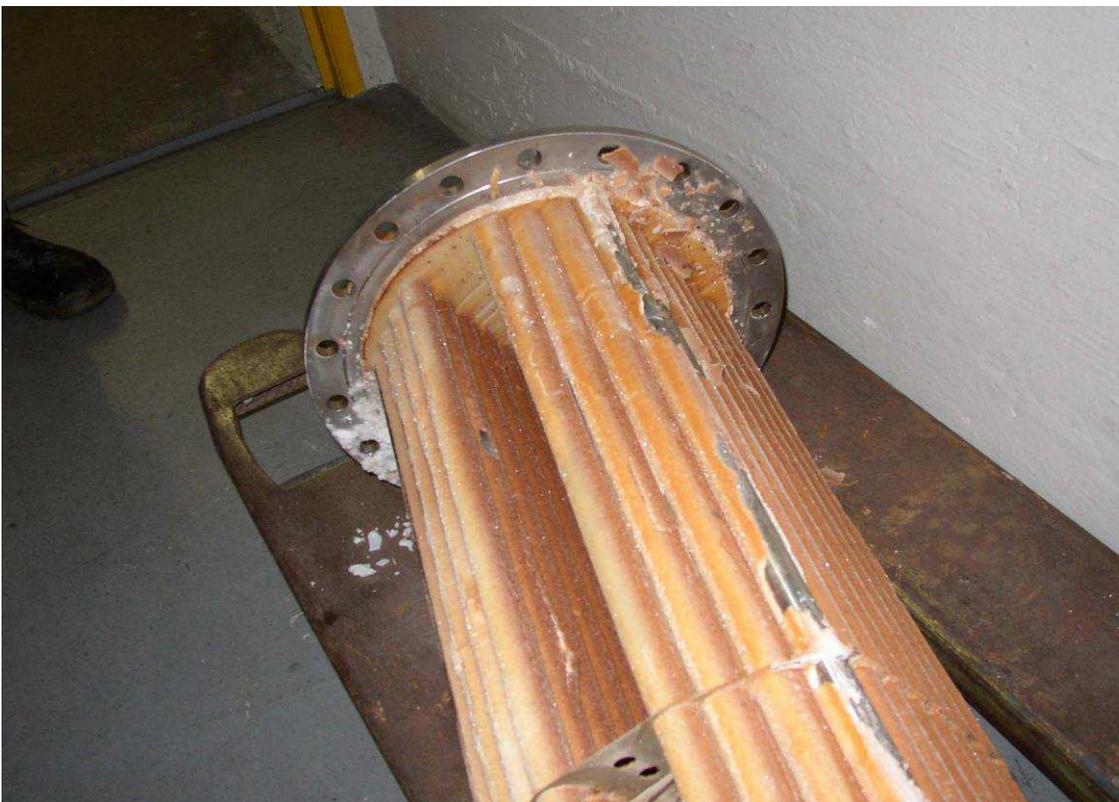
(Fig. 4): The lime-scale is hardened and burned onto the pipes of the heat exchanger and must be dissolved with acid

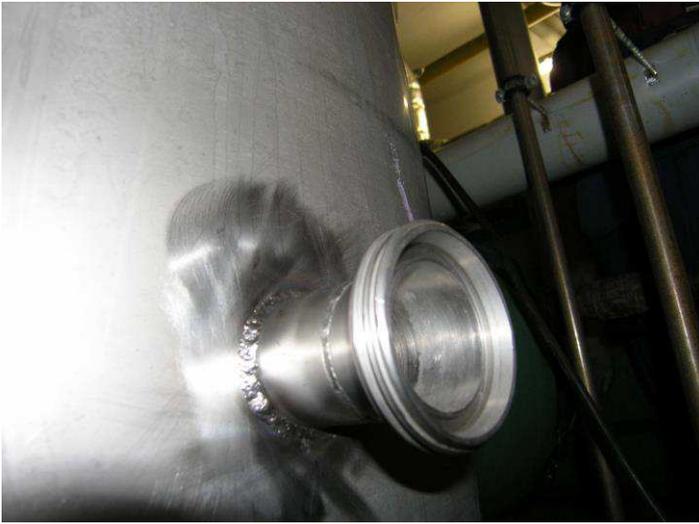
A single ultrasound transducer (speaker) was fitted using a flange, to the outer metal surface of the boiler and second transducer was fitted to the outside of the heat exchanger.

(Fig. 5): Flange for the ultrasound transducer

For these tests, a mounting flange was welded onto the casing of the boiler, as shown in Fig. 5 and Fig. 6.

However, a different mounting method is now used which does not require welding, considerably simplifying the installation process.

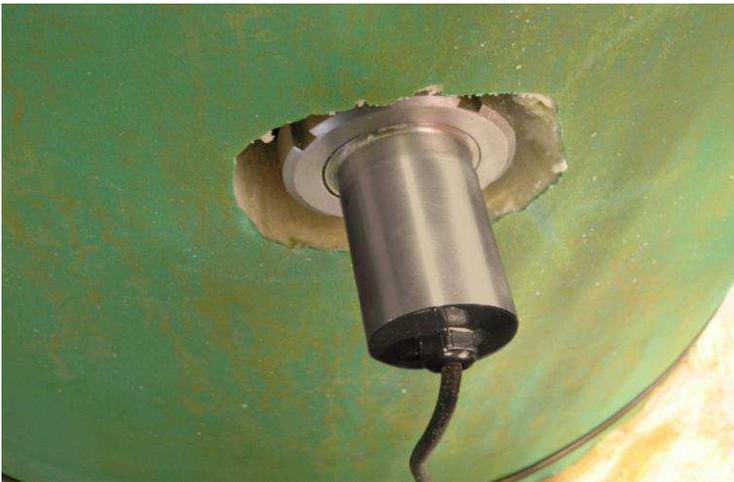
(Fig. 6) Flange with the Smart Sonic Heat transducer.

The boiler's thermal insulation jacket has been suitably cut out and the system is shown ready to run.

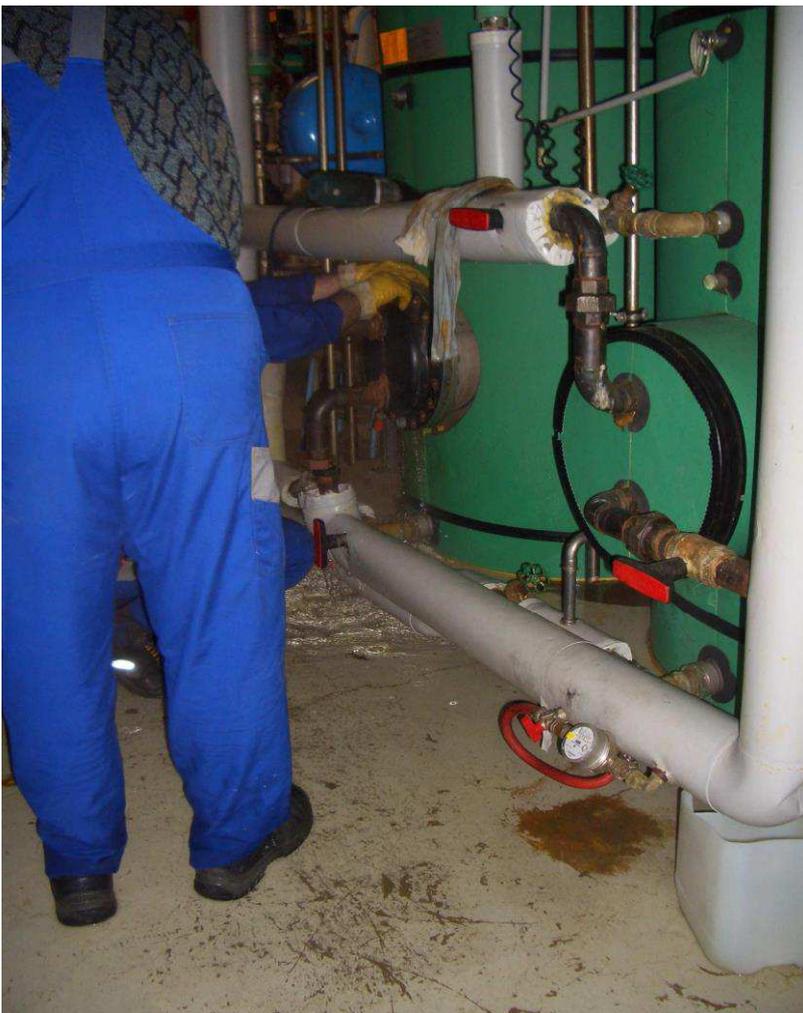
(Fig. 7)
Service Engineers opening the boiler where the Smart Sonic Heat unit had been working for 6 months.

After six months operation, both boilers were opened up for inspection to compare the amount of calcification present inside the boilers and on the heat exchanger bundles.

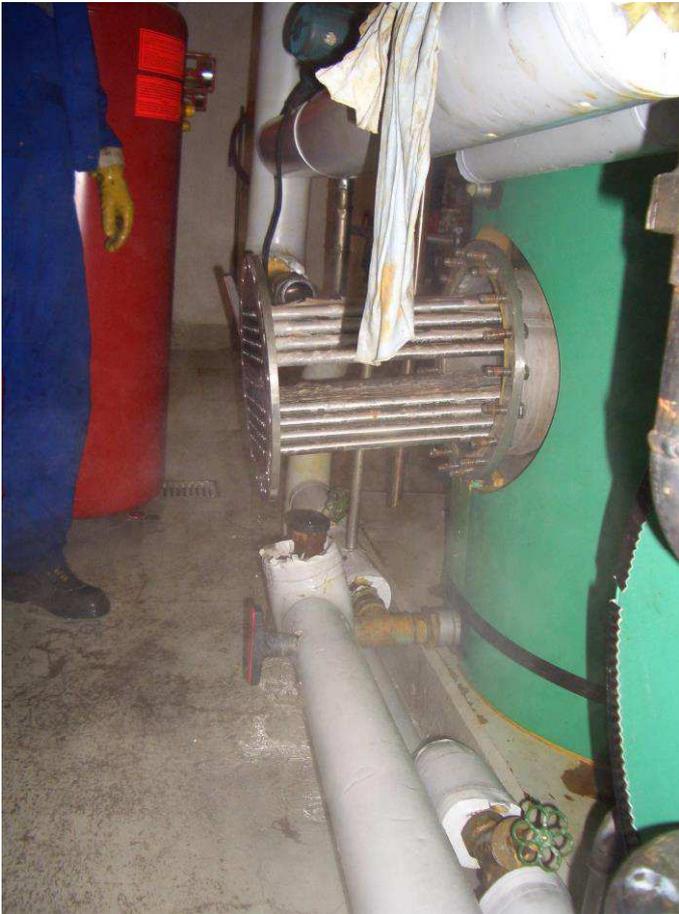
With Smart Heating, by Efficient Sonics

(Fig. 8): The heat exchanger bundle is withdrawn from the boiler. A bit of calcification is visible, but not as much as expected.

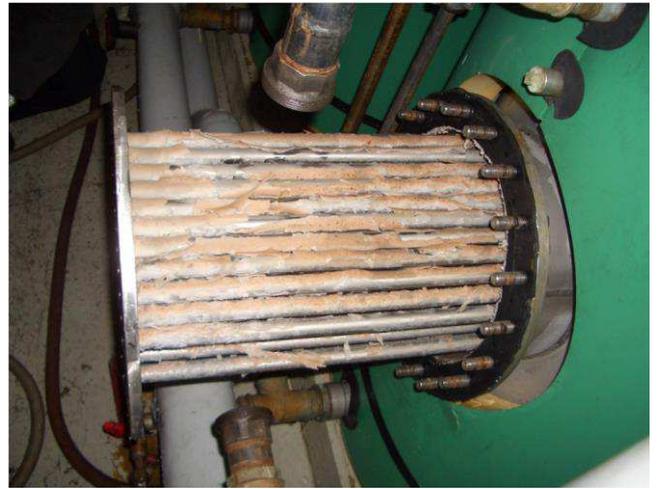
Without Ultrasound device

(Fig. 9): The bundle without ultrasonification has after six months, already developed a pretty thick and hard layer of calcium. Definitely much more than the other bundle.

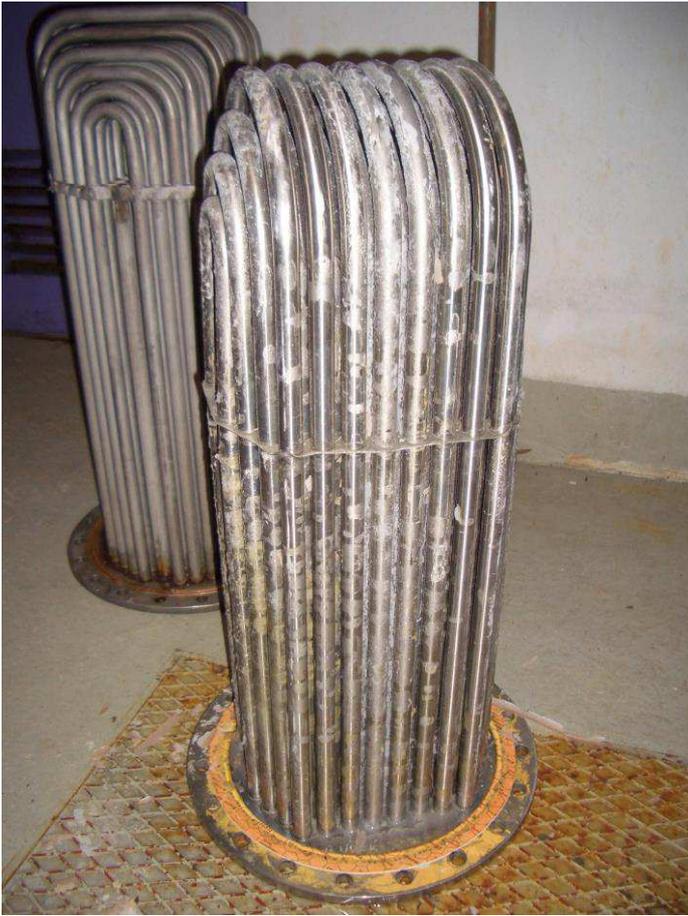
With Smart Heating, by Efficient Sonics

(Fig. 11) Treated with Efficient Sonics Smart Heating

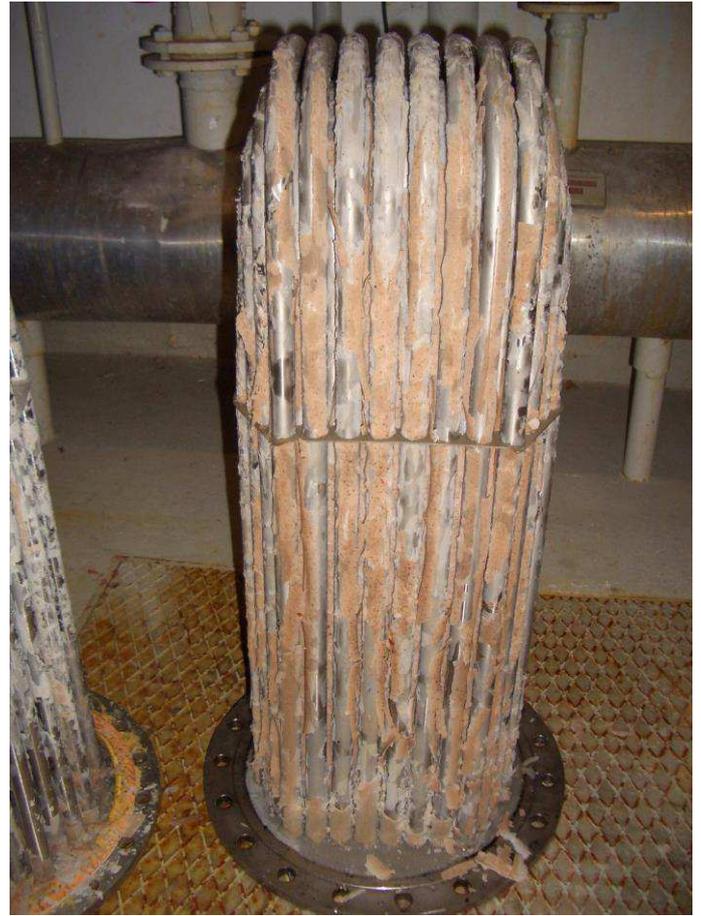
Without Ultrasound

(Fig. 12): No ultrasound treatment

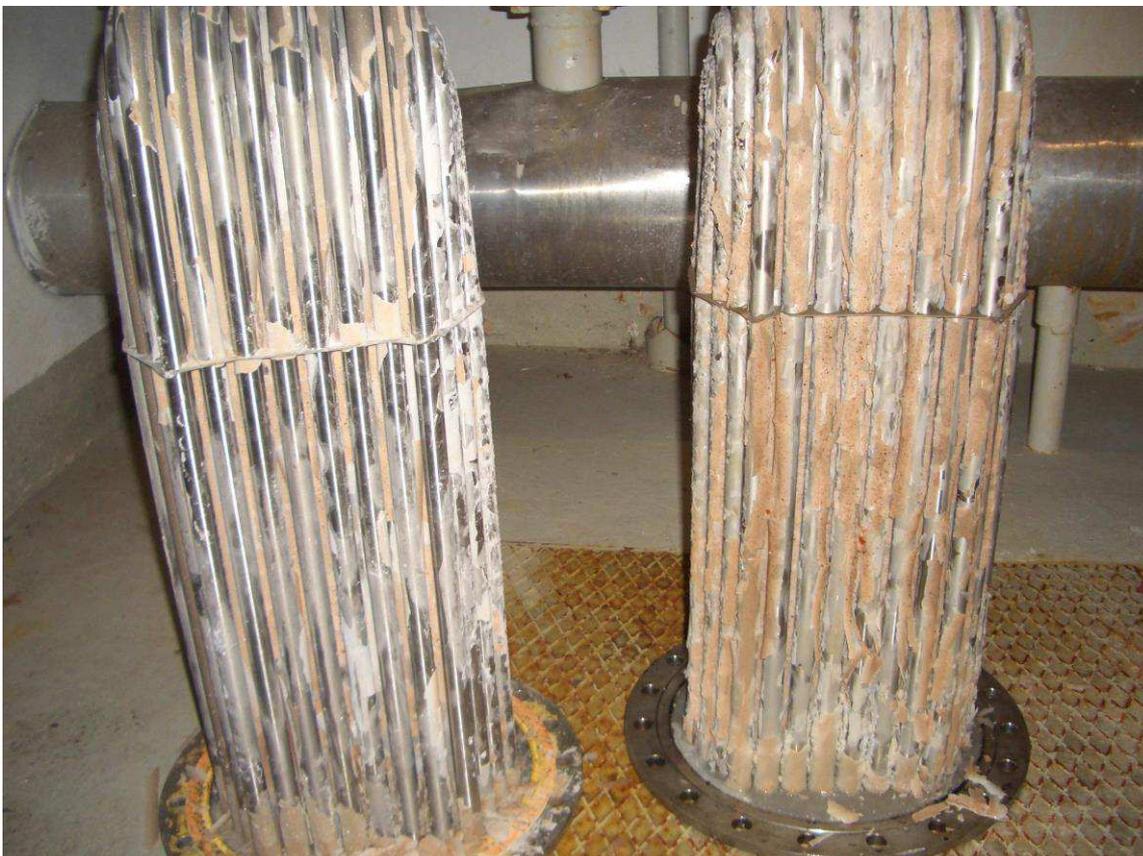
(Fig. 13) Comparing both bundles next to each other, showing approximately 2/3 less calcification!

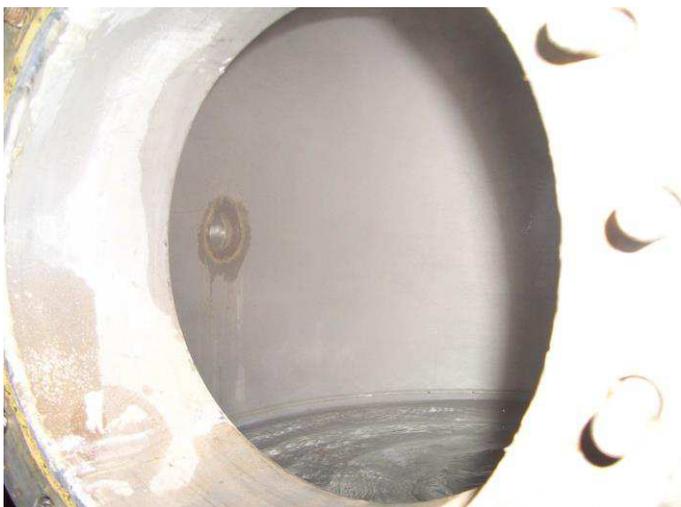
With Smart Heating, by Efficient Sonics

(Fig.14) The boiler wall is very clean. Only on the bottom has a little bit of calcium / lime dust.

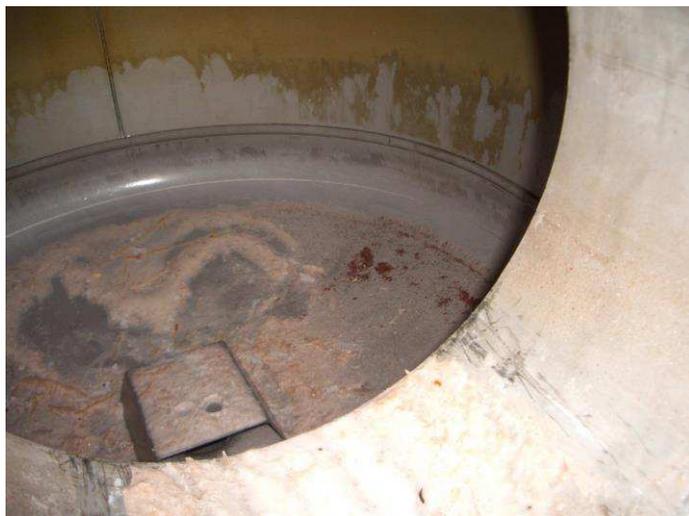
Without Ultrasound

(Fig. 15) Bottom of the boiler without ultrasound. There is a lot of calcium / lime and it is brown and muddy.

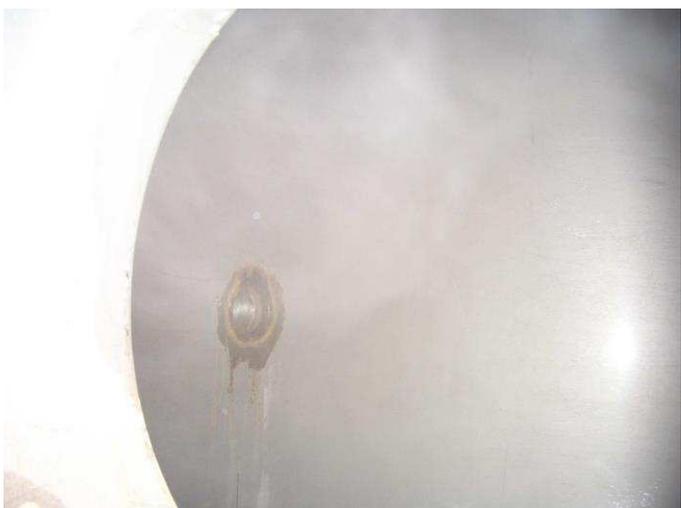
(Fig.16) The boiler wall is totally clean and there is no biofilm visible. No wonder germs have no-where to grow here.

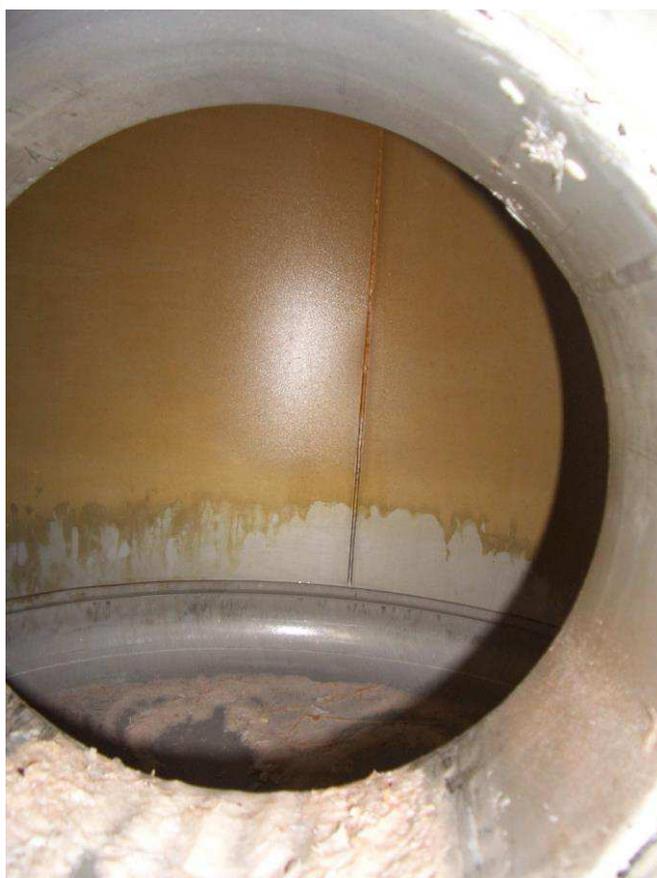
The wall, the bottom and even the inlet for the heat exchanger is very dirty, full of biofilm and calcium. A paradise if you want to breed germs.

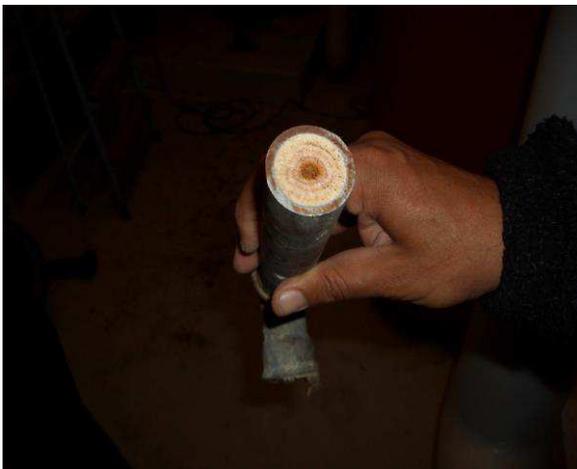
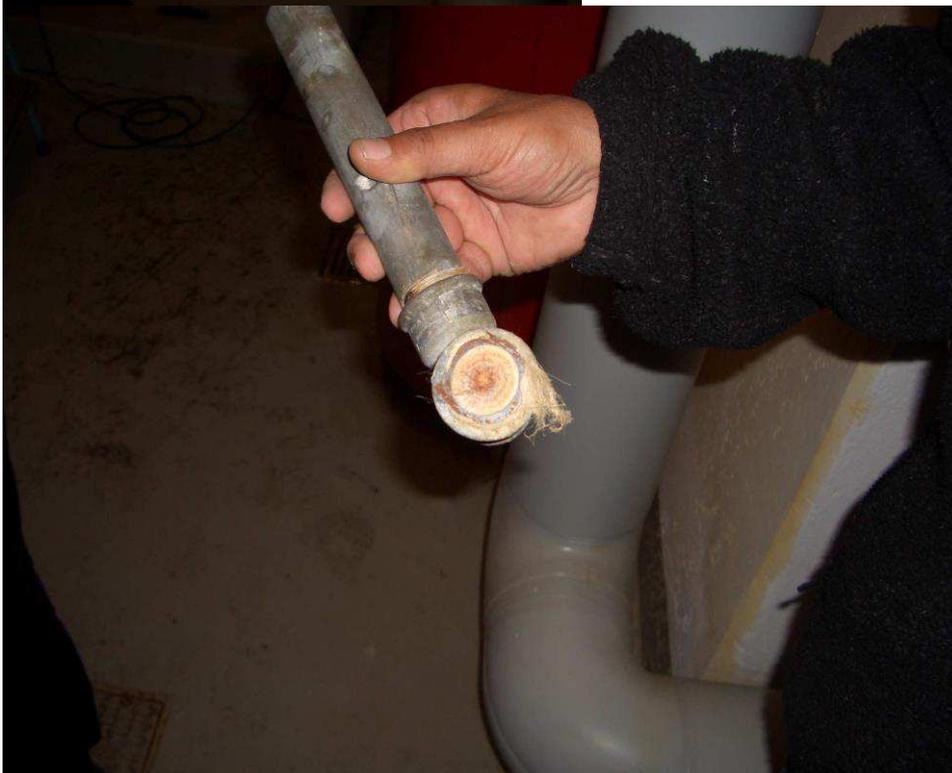
This is how a typical water pipe in Munich looks after 21 years use!!! It is blocked up!
